# Test Report

Report No.: SZPA1205101208401E-2R1

Sample Name : Liquid photoimageable solder resist ink H-9100(H-8100)

**Test Results:** All the test item results meet the requirement of IPC-SM-840D.

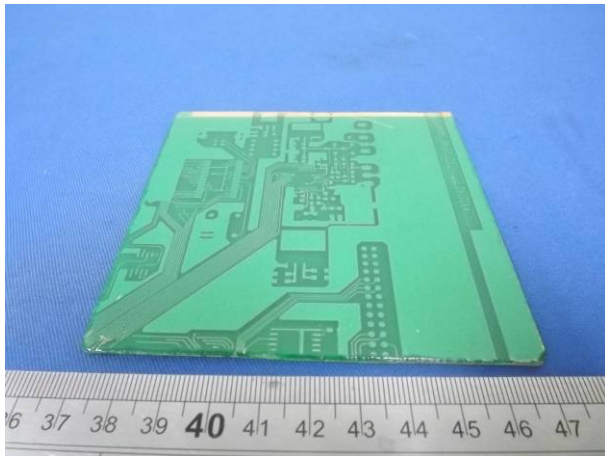
**Fig1.** Sample PA120510012-1

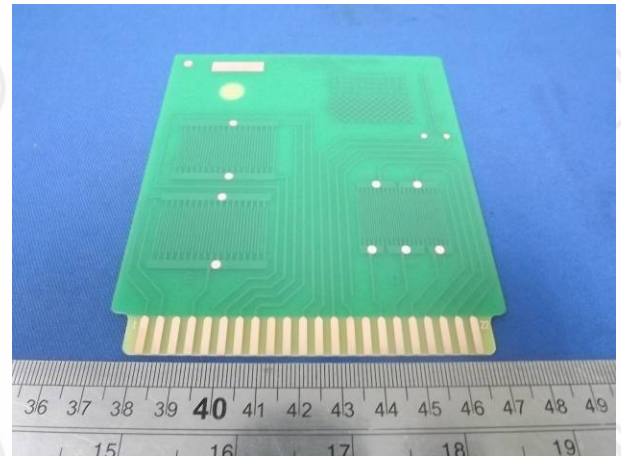
**Fig2.** Sample PA120510012-2

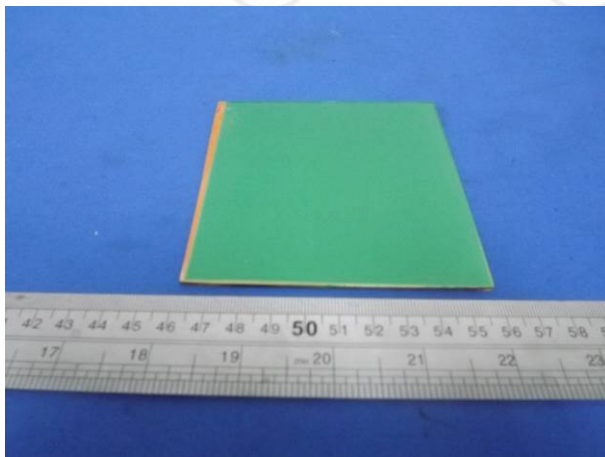
**Fig3.** Sample PA120510012-3

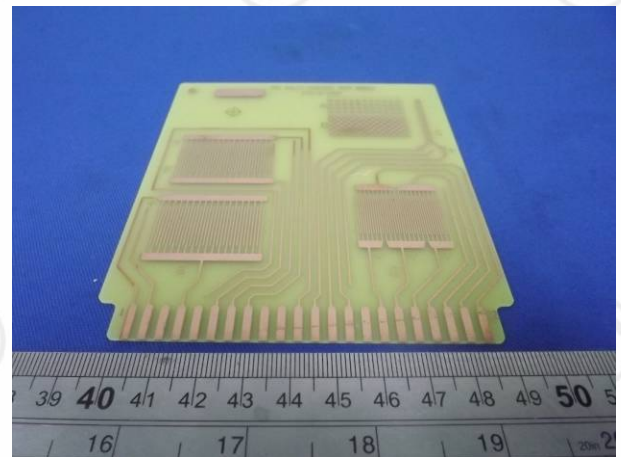
**Fig4.** Reference board photo before test

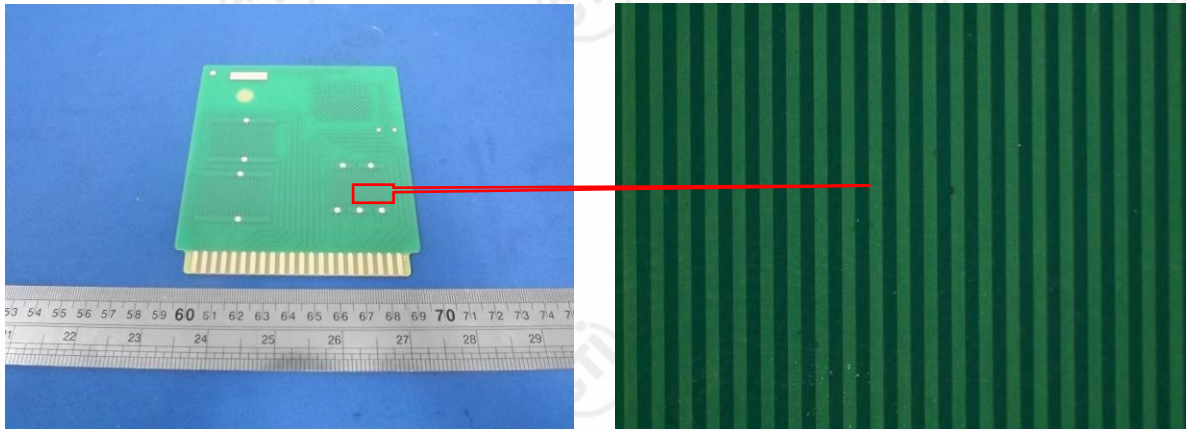
**Fig5.** Sample PA120510012-2 before soldering (solder resist ink coating) test board photo after test

Test Sample			Insulation resistance ( $\Omega$ )		
			Readings in 18th cycle high temperature phase	Reading taken outside the chamber	Requirements
PA120510012-2	Before Soldering (solder resist ink coating board)	1-2	$3.56 \times 10^9$	$1.22 \times 10^{11}$	$\geq 5 \times 10^8$
		2-3	$3.35 \times 10^{10}$	$9.86 \times 10^{10}$	
		3-4	$6.28 \times 10^{10}$	$2.60 \times 10^{10}$	
		4-5	$4.76 \times 10^9$	$2.09 \times 10^{10}$	
	After Soldering (solder resist ink coating board)	1-2	$1.59 \times 10^{10}$	$3.24 \times 10^{10}$	
		2-3	$1.93 \times 10^{10}$	$3.38 \times 10^{10}$	
		3-4	$1.33 \times 10^{10}$	$2.73 \times 10^{10}$	
		4-5	$1.34 \times 10^{10}$	$8.33 \times 10^{10}$	
	Reference board (Uncoated board)	1-2	$9.71 \times 10^9$	$1.18 \times 10^{11}$	
		2-3	$1.17 \times 10^9$	$1.88 \times 10^{10}$	
		3-4	$1.43 \times 10^9$	$2.27 \times 10^{10}$	
		4-5	$3.70 \times 10^8$	$2.01 \times 10^{10}$

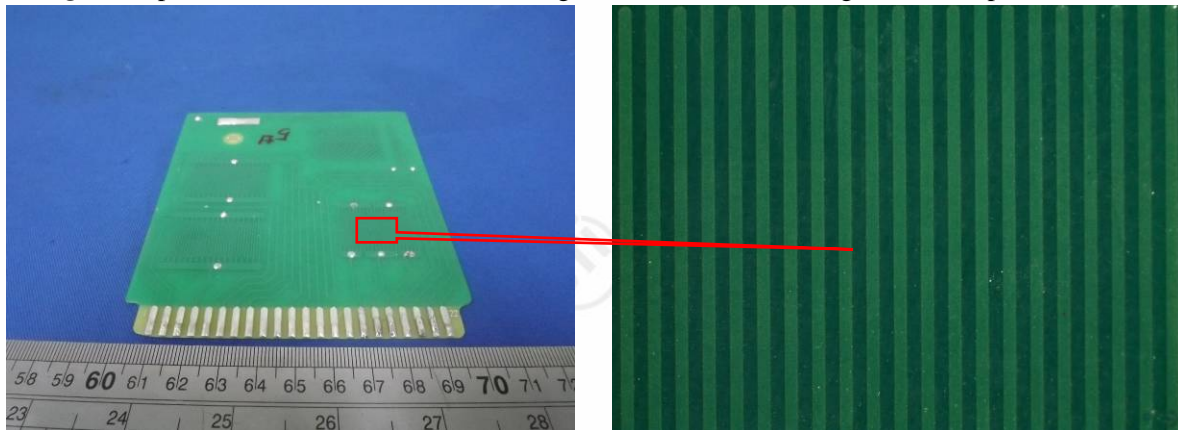
**Fig6.** Sample PA120510012-2 after soldering (solder resist ink coating) test board photo after test

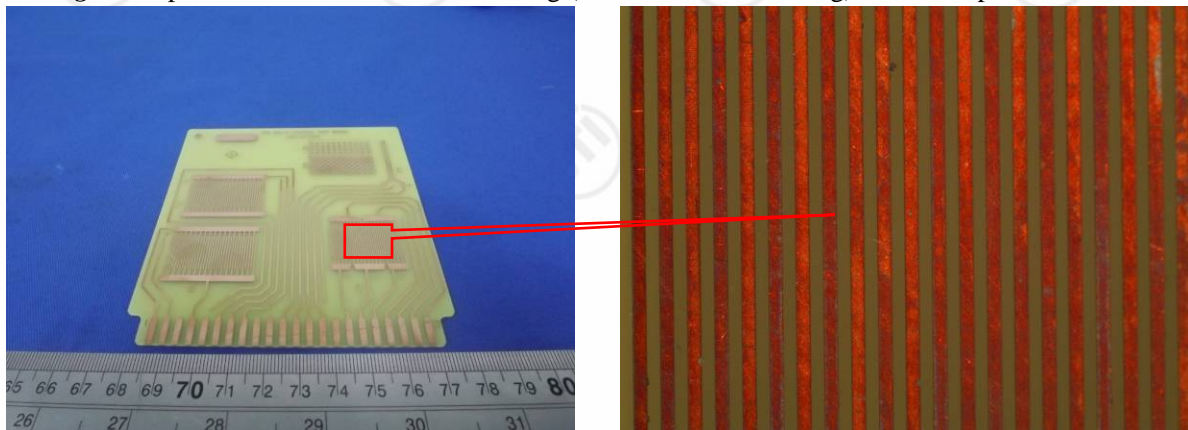
**Fig7.** Sample PA120510012-2 reference board (Uncoated board) photo after test

**Remark:** Insulation resistance readings in 18th cycle high temperature phase for Reference board (Uncoated board) 4-5 position is abnormal and caused by environment vibration etc.

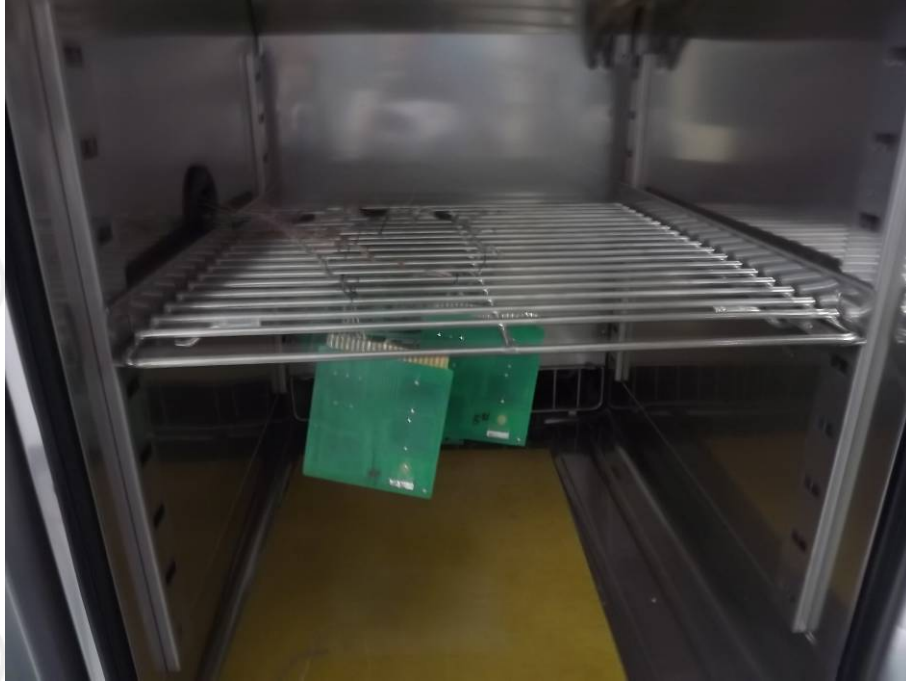
*Fig8.* Sample photo during moisture and insulation resistance test

(5) **Test Condition:** Dry and connect treatment the reference board(Uncoated board), standard test board with solder resist ink coating and standard test board with solder resist ink coating after solder. After treatment, put both the testing board and the reference board in constant temperature & humidity chamber for 20cycles. And the cycle temperature is 25~65°C. Humidity is 90%RH. 50VDC bias voltage shall be applied between the electrodes. Insulation resistance for the final (18th cycle) readings in high temperature phase in the chamber and the reading taken outside the chamber shall be used to determine pass/fail criteria. Test voltage: 100V DC; Test time: 1 min. Finally examine at 10 X with stereoscopic microscope.

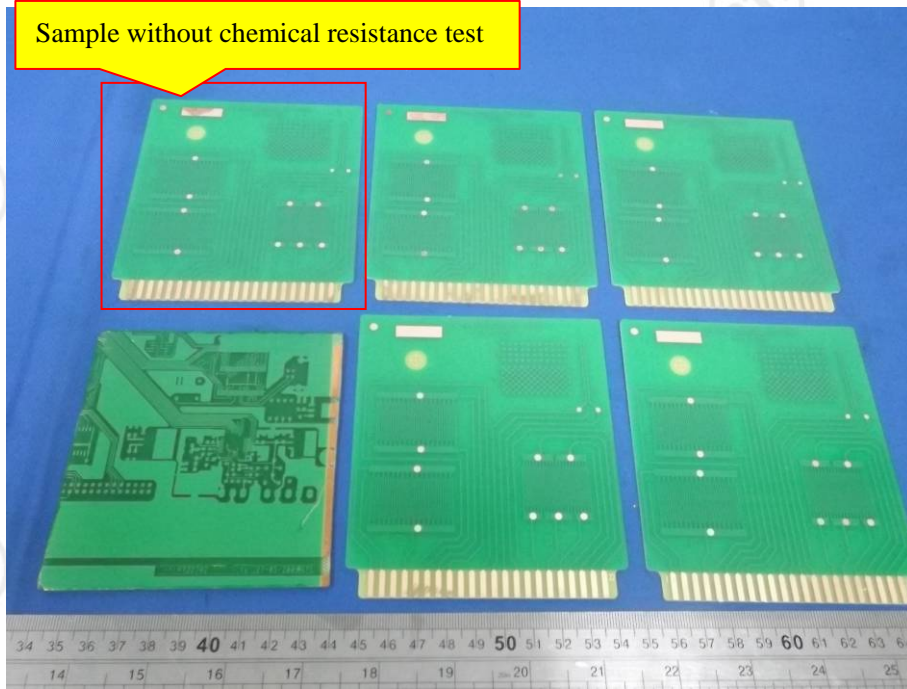
*Fig9.* After resistance to isopropanol

Tested sample	Test Result
PA120510012-1, PA120510012-2	No delamination or surface degradation such as cracks, tackiness, blisters or swelling of the solder mask can be found. See Fig 9
	No delamination or surface degradation such as cracks, tackiness, blisters or swelling of the solder mask can be found. See Fig 10
	No delamination or surface degradation such as cracks, tackiness, blisters or swelling of the solder mask can be found. See Fig 11
	No delamination or surface degradation such as cracks, tackiness, blisters or swelling of the solder mask can be found. See Fig 12
	No delamination or surface degradation such as cracks, tackiness, blisters or swelling of the solder mask can be found. See Fig 13
	No delamination or surface degradation such as cracks, tackiness, blisters or swelling of the solder mask can be found. See Fig 14

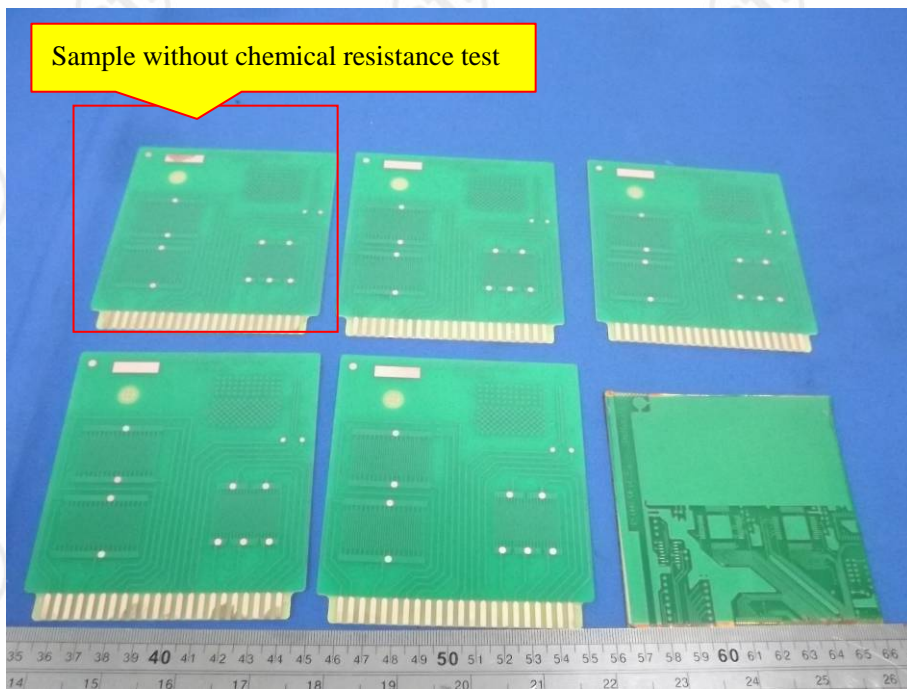
*Fig10.* After resistance to 75% isopropanol+25% deionized water

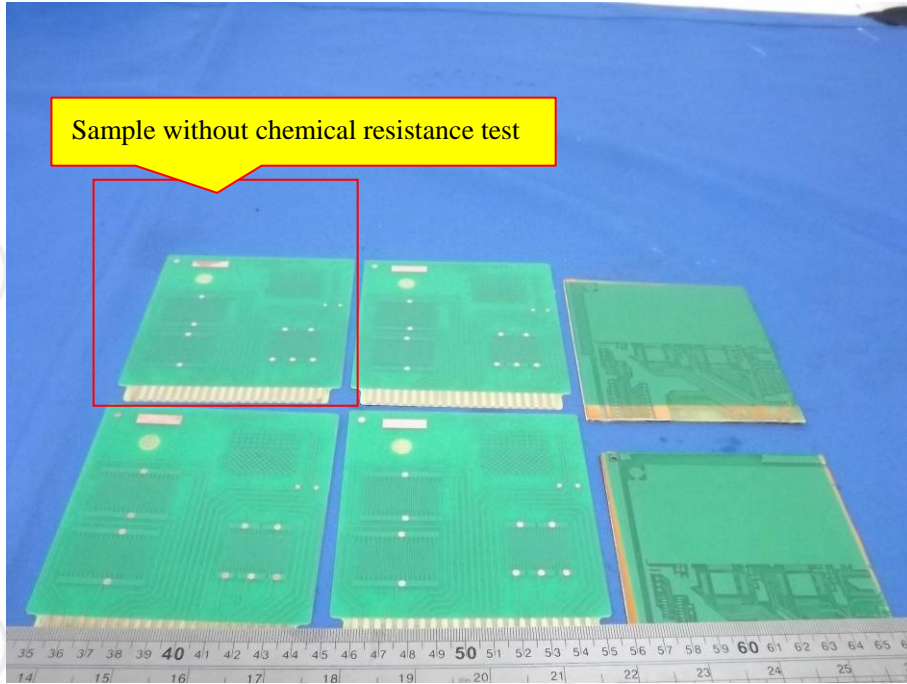
**Fig11.** After resistance to 10% alkaline detergent

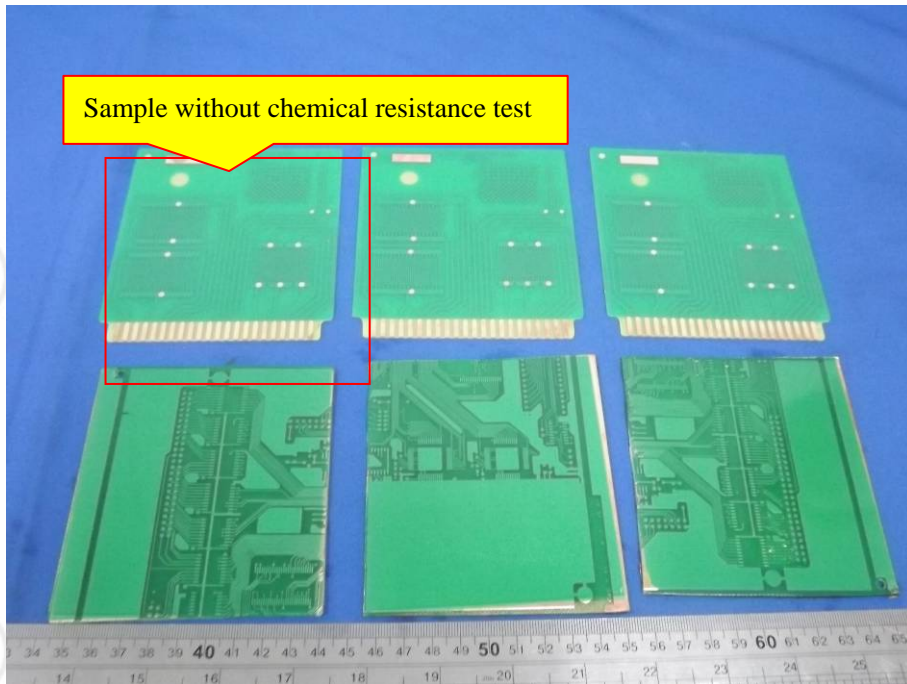
**Fig12.** After resistance to monoethanolamine

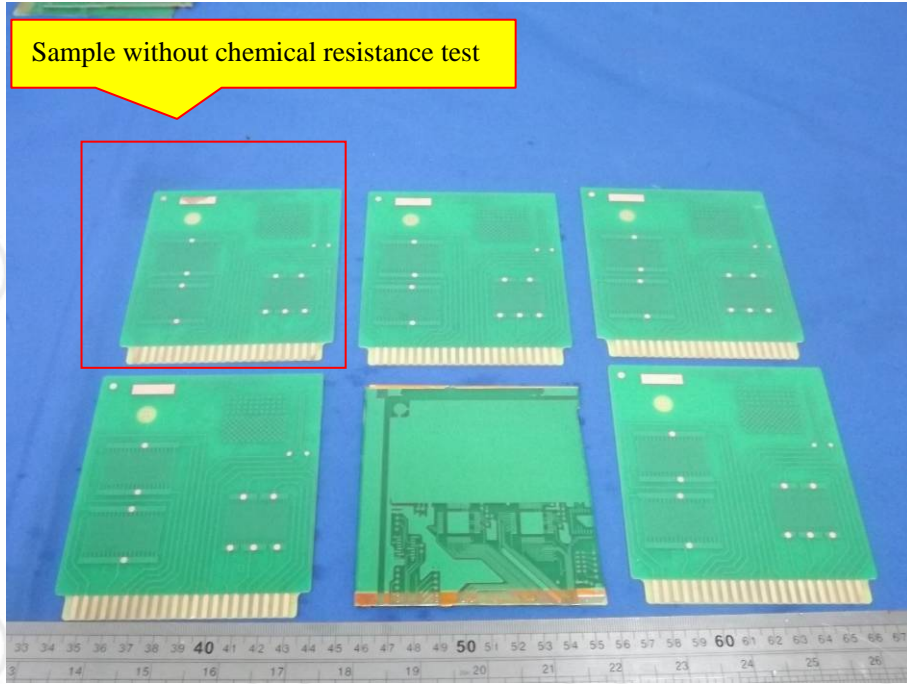
**Fig13.** After resistance to deionized water

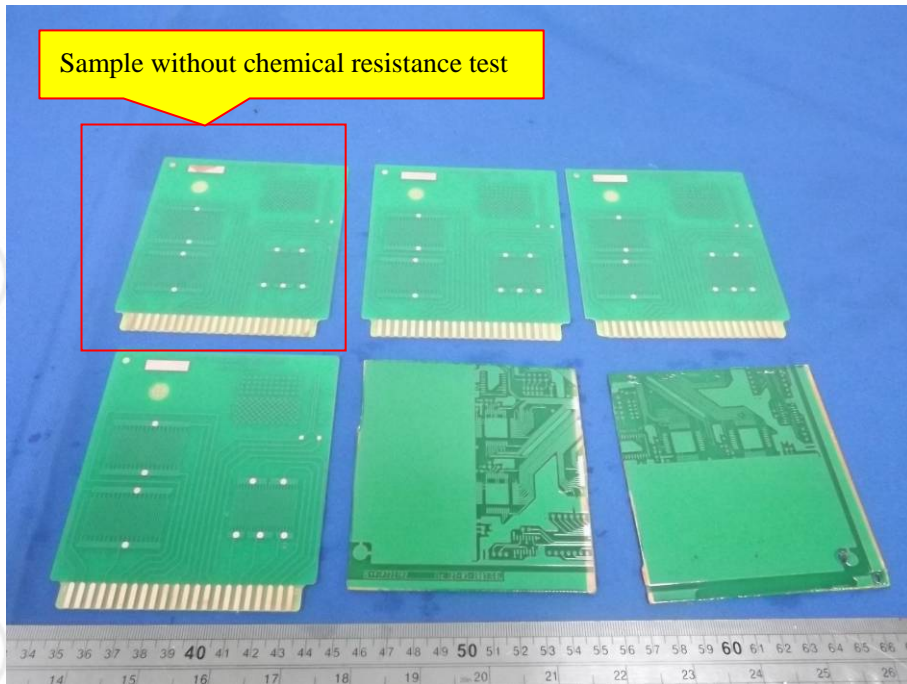
**Fig14.** After resistance to D-Limonene

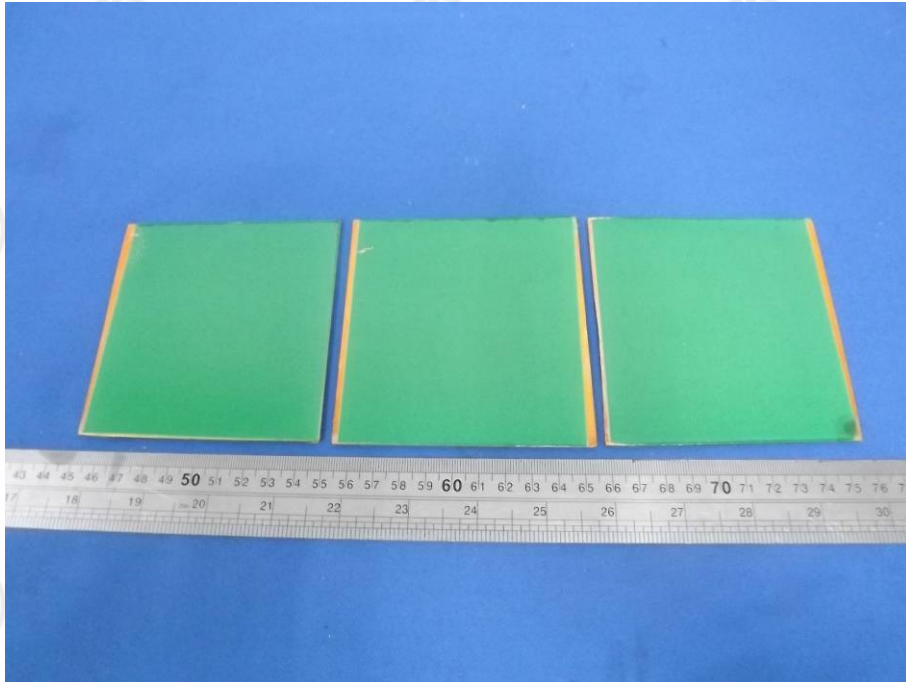
**Fig15.** Sample PA120510012-3 photo before hydrolytic stability test

Test sample	Test Result
PA120510012-3	No chalking, blistering, cracking and general degradation can be found. See Fig15. ~Fig16.

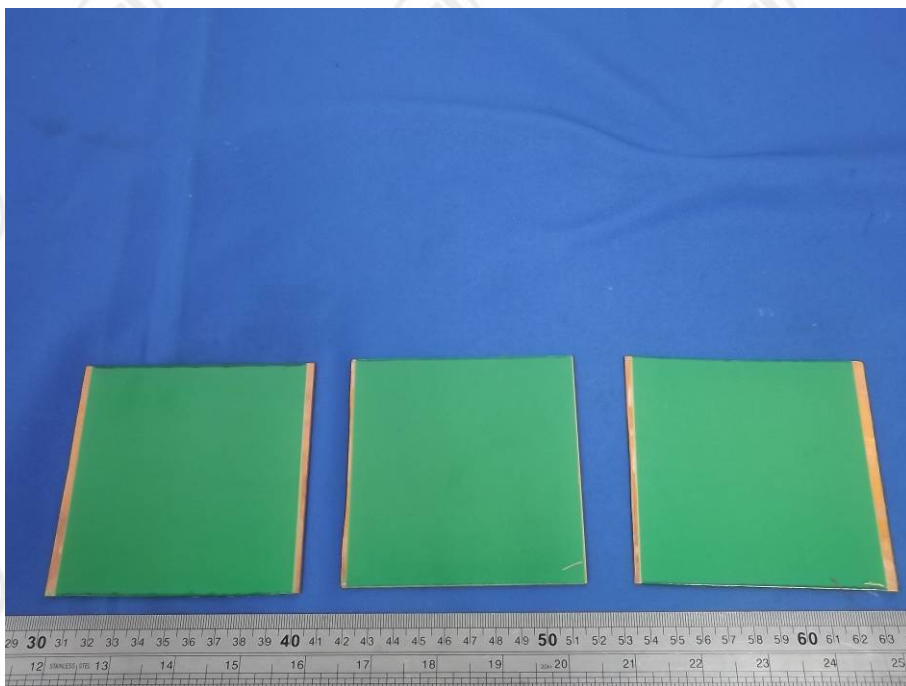
**Fig16.** Sample PA120510012-3 photo after hydrolytic stability test

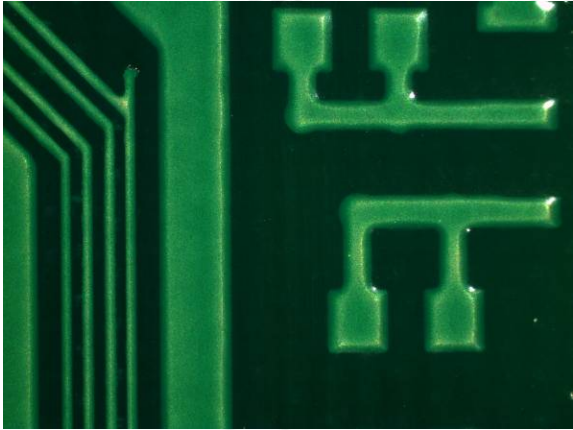
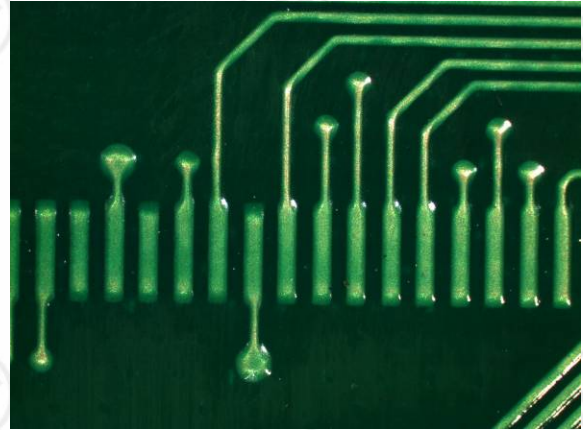
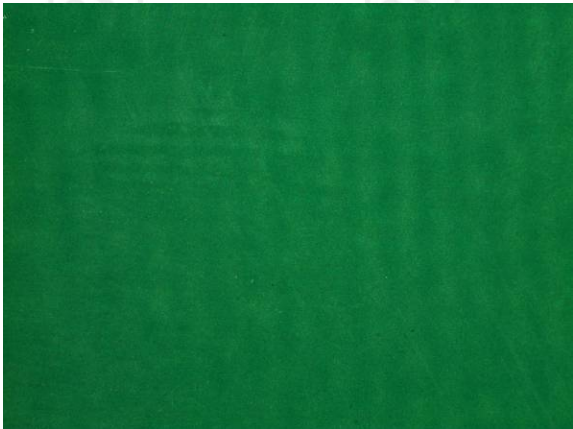
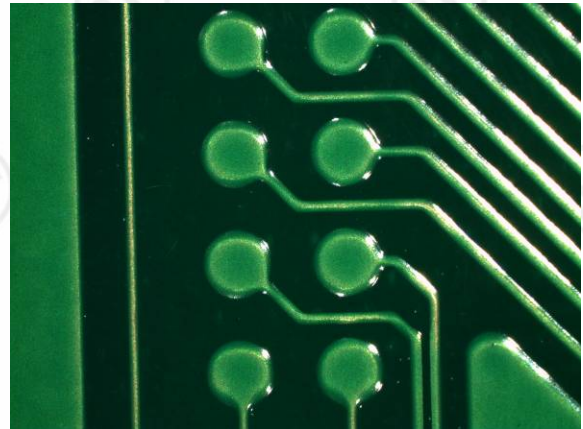
**Fig17.** Sample PA120510012-1 appearance typical  
photo 1 (10 X)

**Fig18.** Sample PA120510012-1 appearance typical  
photo 2 (10X)

**Fig19.** Sample PA120510012-1 appearance typical  
photo 3 (10 X)

**Fig20.** Sample PA120510012-1 appearance typical  
photo 4 (10 X)

Tested Sample	Test Results
PA120510012-1	No visual crack, peeling, blistering, delamination and chalking defects

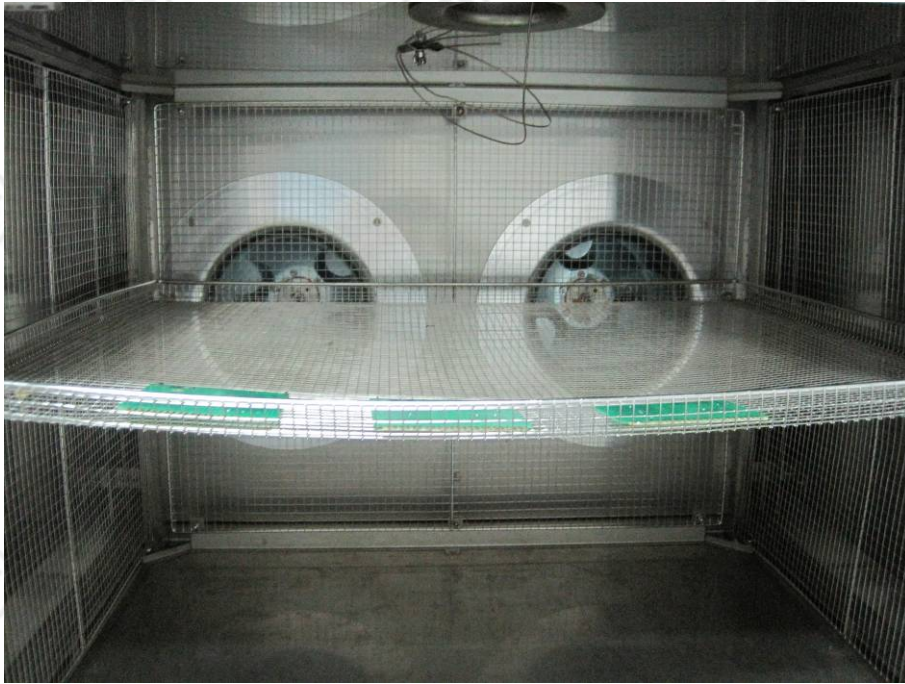
**Fig21.** Sample PA120510012-2 photo during thermal shock test

low temperature -65°C; high temperature 125°C, dwell time 15 min; Transition time: less than 2min;

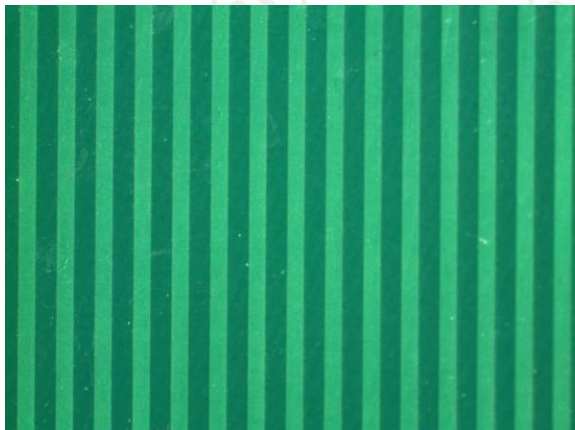
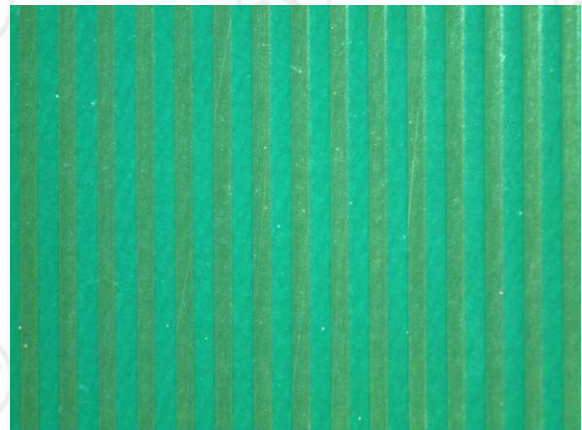
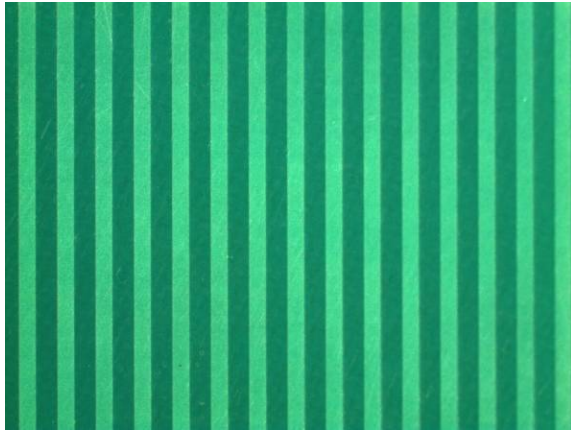
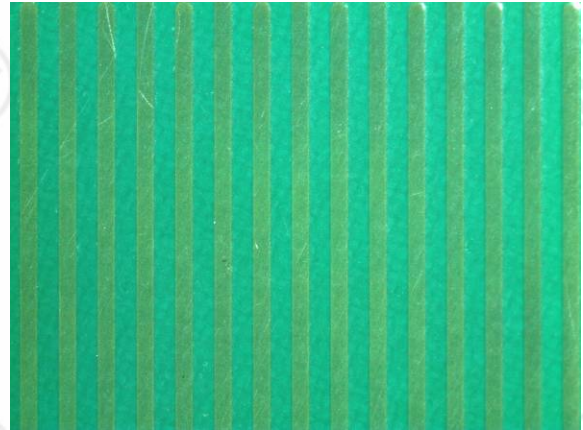
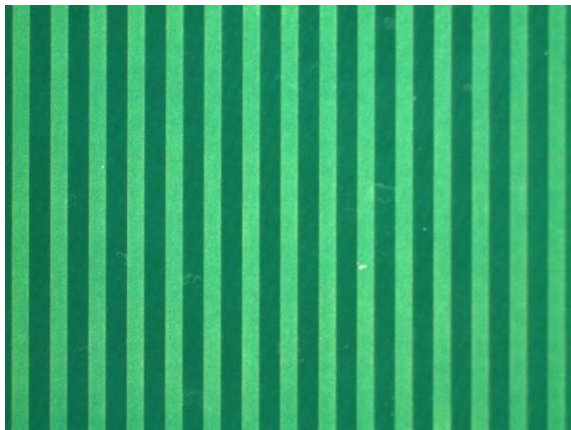
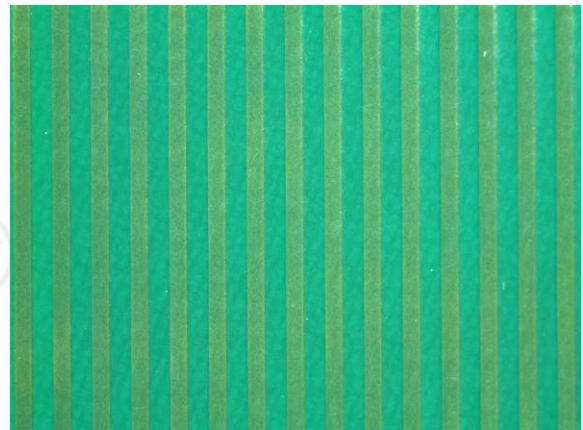
**Fig22.** Sample PA120510012-2 typical photo1  
before thermal shock test (10 X)

**Fig23.** Sample PA120510012-2 typical photo 1  
after thermal shock test (10 X)

**Fig24.** Sample PA120510012-2 typical photo 2  
before thermal shock test (10 X)

**Fig25.** Sample PA120510012-2 typical photo 2  
after thermal shock test (10 X)

**Fig26.** Sample PA120510012-2 typical photo 3  
before thermal shock test (10 X)

**Fig27.** Sample PA120510012-2 typical photo 3  
after thermal shock test (10 X)

Tested Sample	Test Results	
PA120510012-2	1	No blisters, crazing and delamination
	2	No blisters, crazing and delamination
	3	No blisters, crazing and delamination

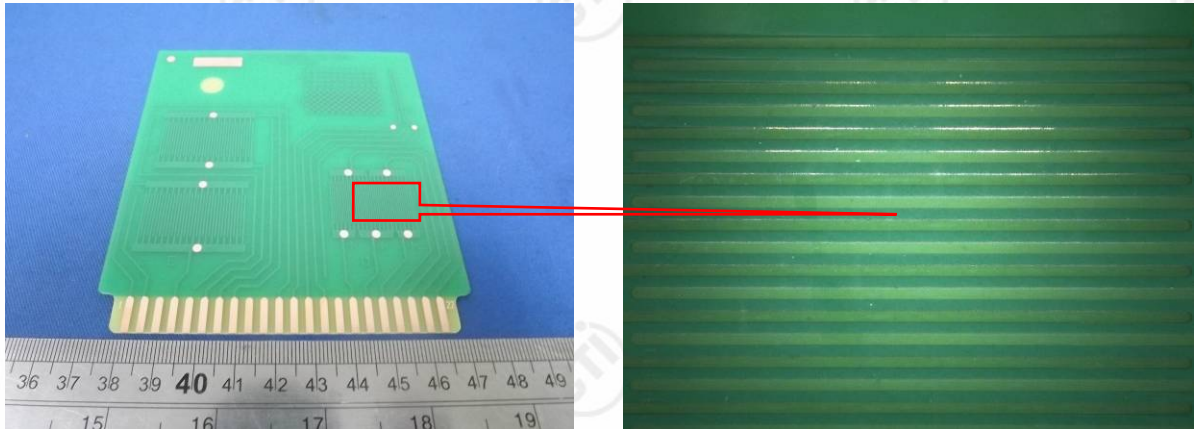
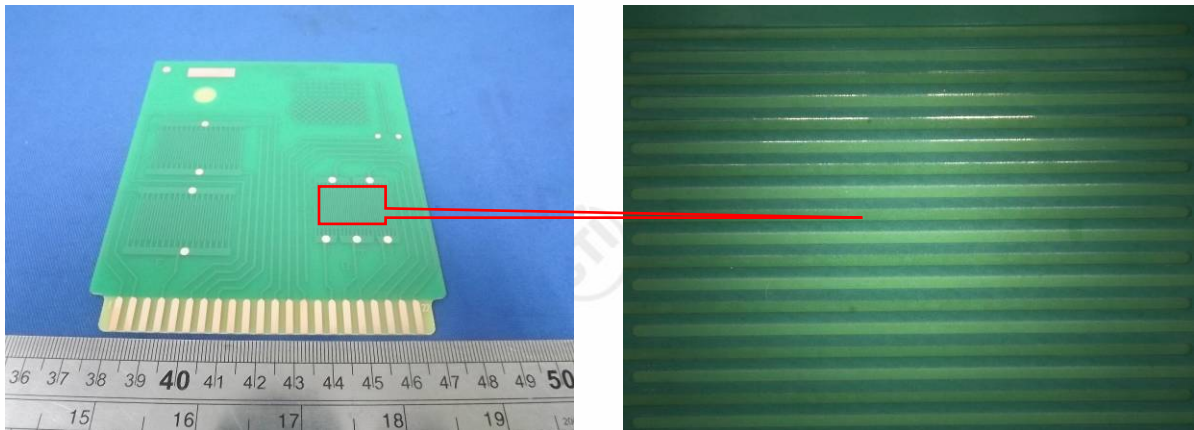
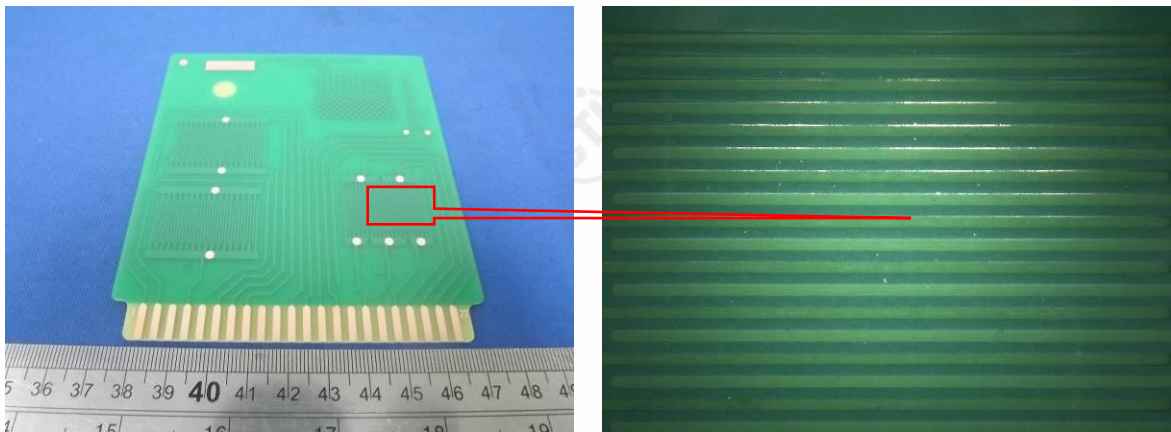
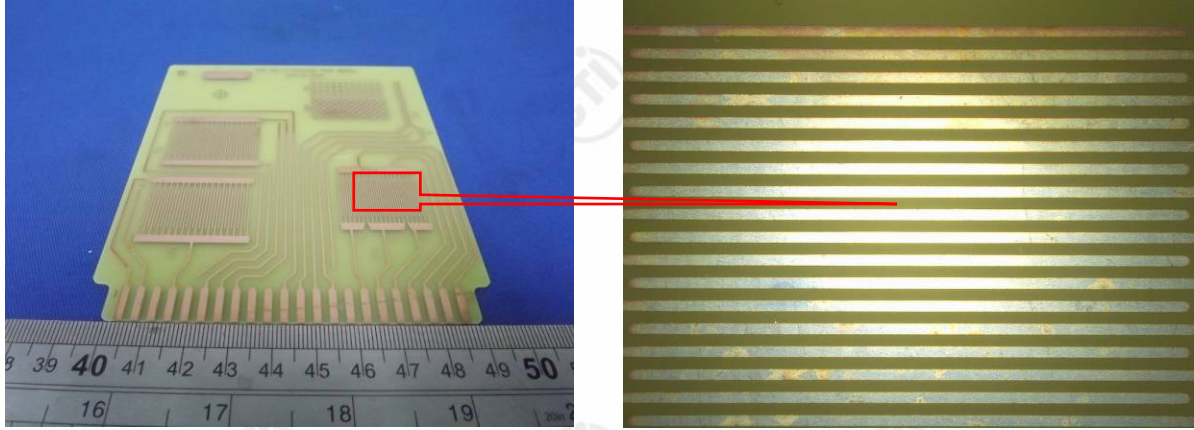
**Fig28.** Sample PA120510012-2 test board 1 photo after test

**Fig29.** Sample PA120510012-2 test board 2 photo after test

**Fig30.** Sample PA120510012-2 test board 3 photo after test

**Fig31.** Sample PA120510012-2 Reference board photo after test

Test Sample				Test Results ( $\Omega$ )		
				Before Test	After Test	Requirements
PA120510012-2	Solder resist ink coating board	1	1-2	$1.00 \times 10^{11}$	$1.67 \times 10^{10}$	$\geq 2 \times 10^6$
			2-3	$1.00 \times 10^{11}$	$2.50 \times 10^{10}$	
			3-4	$1.00 \times 10^{11}$	$5.00 \times 10^{10}$	
			4-5	$1.00 \times 10^{11}$	$1.00 \times 10^{11}$	
		2	1-2	$1.00 \times 10^{11}$	$5.00 \times 10^{10}$	
			2-3	$1.00 \times 10^{11}$	$1.00 \times 10^{11}$	
			3-4	$1.00 \times 10^{11}$	$1.00 \times 10^{11}$	
			4-5	$5.00 \times 10^{11}$	$5.00 \times 10^{10}$	
		3	1-2	$1.00 \times 10^{11}$	$1.43 \times 10^{10}$	
			2-3	$5.00 \times 10^{11}$	$1.43 \times 10^{10}$	
			3-4	$1.00 \times 10^{11}$	$3.33 \times 10^{10}$	
			4-5	$1.00 \times 10^{11}$	$1.00 \times 10^{11}$	
	Reference board (Uncoated board)	1-2	$3.33 \times 10^{10}$	$2.50 \times 10^{10}$		
		2-3	$1.00 \times 10^{11}$	$3.33 \times 10^{10}$		
		3-4	$1.00 \times 10^{11}$	$1.67 \times 10^{10}$

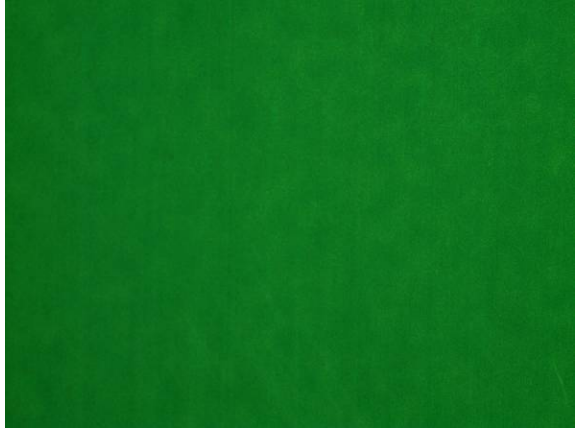
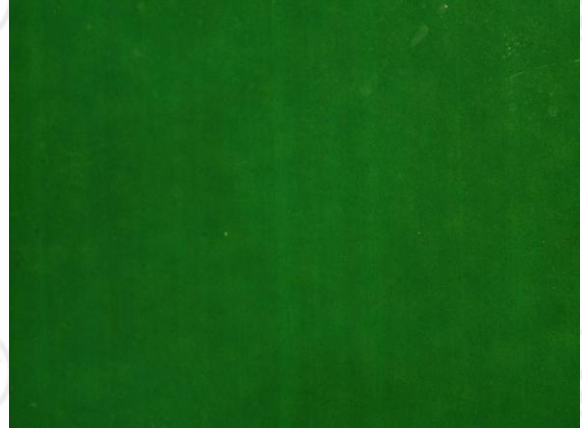
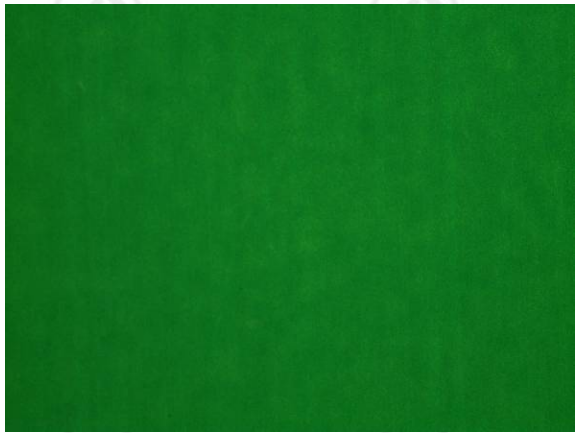
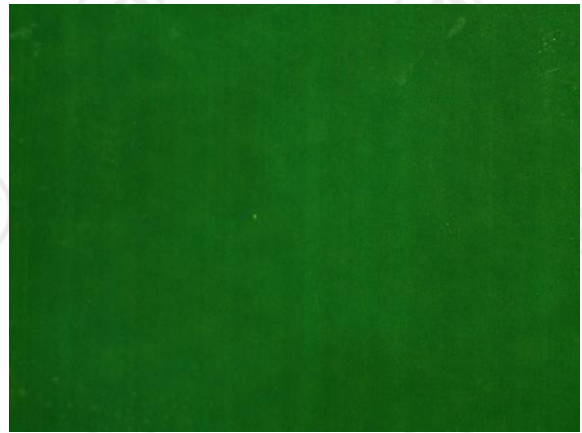
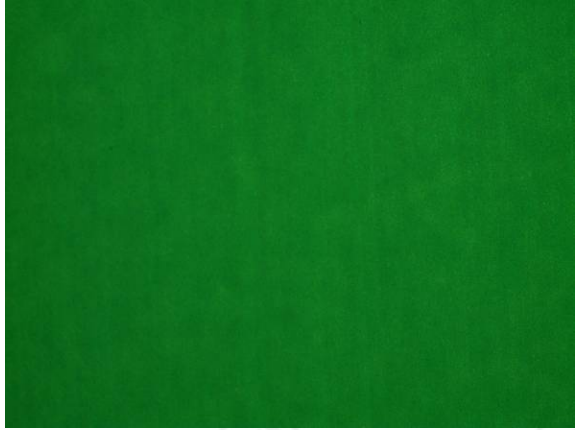
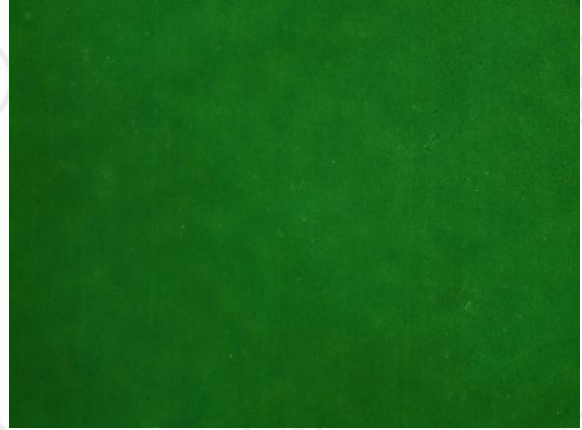
**Fig32.** Sample PA120510012-3 before the picture 1  
(10 X)

**Fig33.** Sample PA120510012-3 after test picture 1  
(10 X)

**Fig34.** Sample PA120510012-3 before the picture 2  
(10 X)

**Fig35.** Sample PA120510012-3 after test picture 2  
(10 X)

**Fig36.** Sample PA120510012-3 before the picture 3  
(10 X)

**Fig37.** Sample PA120510012-3 after test picture 3  
(10 X)

Tested Sample		Test Results
PA120510012-3	1	No delamination, blisters and crazing defects
	2	No delamination, blisters and crazing defects
	3	No delamination, blisters and crazing defects

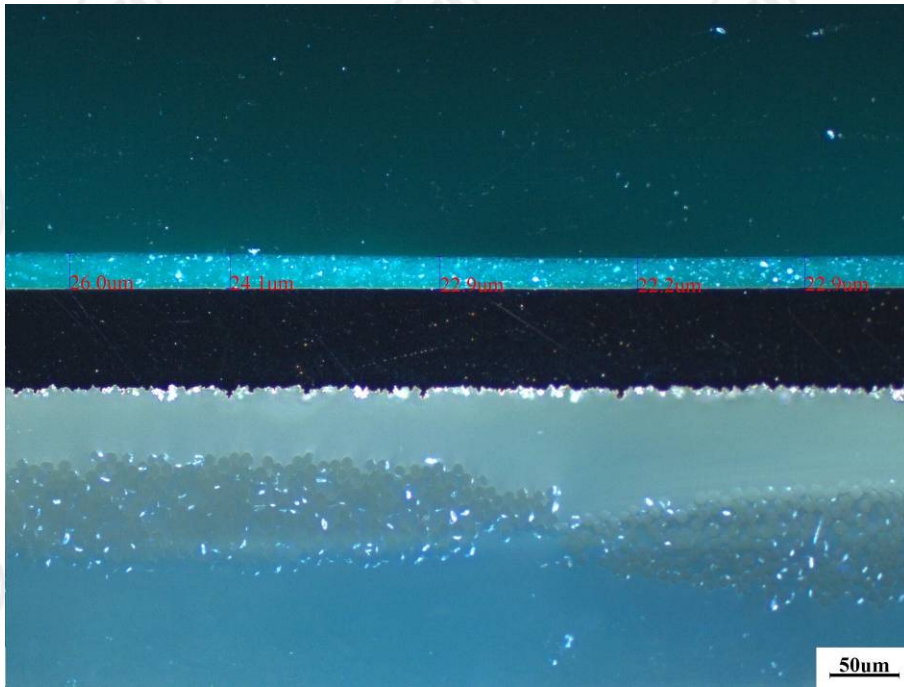
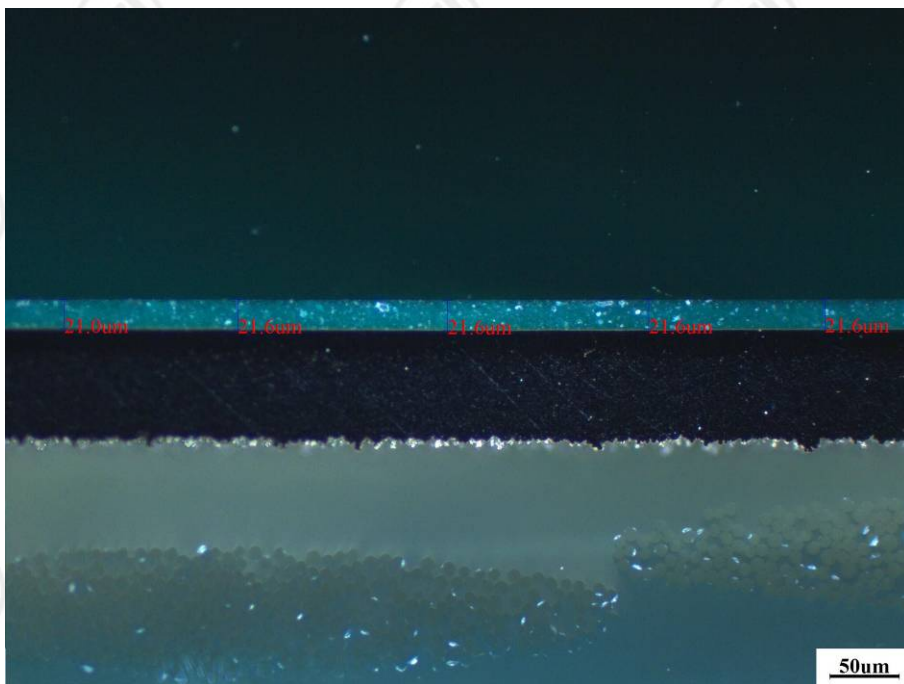
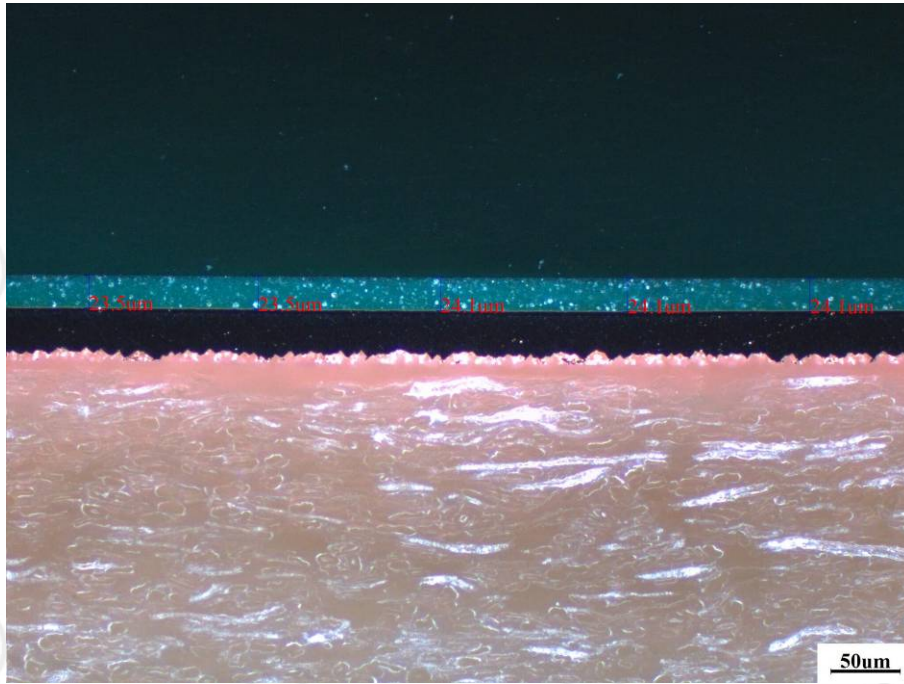
**Fig38.** Solder resist ink thickness cross section photo of sample PA120510012-1-1 (200X)

**Fig39.** Solder resist ink thickness cross section photo of sample PA120510012-1-2 (200X)

**Fig40.** Solder resist ink thickness cross section photo of sample PA120510012-3 (200X)

Tested Sample		Test Position	Solder resist ink thickness					Unit: $\mu\text{m}$
			Point1	Point 2	Point 3	Point 4	Point 5	Ave.
PA120510012-1	1	Solder resist ink	26.0	24.1	22.9	22.2	22.9	23.6
	2		21.0	21.6	21.6	21.6	21.6	21.5
PA120510012-3			23.5	23.5	24.1	24.1	24.1	23.9
